# Hoek & Brown Collapse Criteria Method on The Road Section of Lende Tovea Village, Sirenja District, Donggala Regency

<sup>1</sup>Program Studi S1 Teknik Geologi, Fakultas Teknik, Universitas Tadulako, Indonesia.

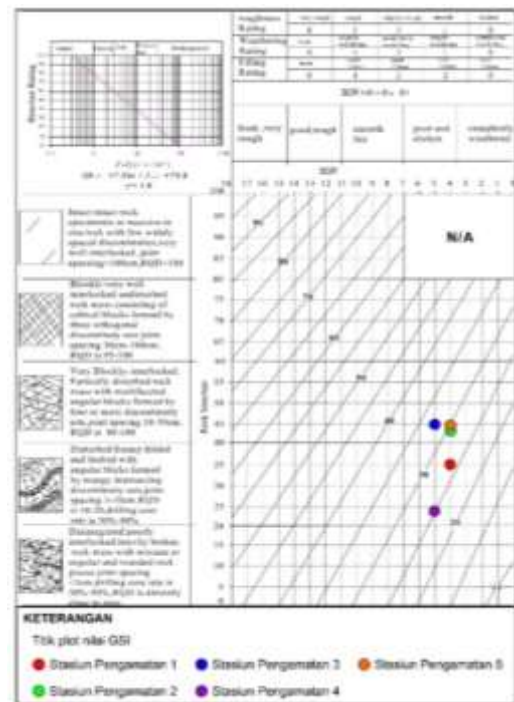
At stations 1 and 4, the rock mass conditions, in addition to experiencing deformation due to tectonic processes, also experienced a process of degradation resulting from water due to high rainfall intensity in mountainous areas. At stations 2, 3, and 5, the rock mass conditions on the slopes that experienced rock deformation processes resulted in slope outcrops in the lithology being fractured and faulted and experiencing weathering so that the rock mass encountered was in poor condition and disturbed (Kudapa et al., 2023; Silwal et al., 2024; D. Singh et al., 2022).

Figure 4. GSI values based on rock mass observations at stations 1, 2, 3, 4 and 5

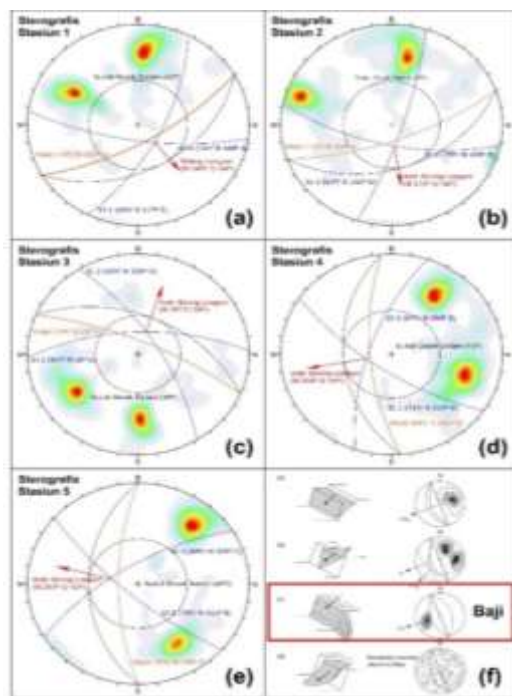
**Figure 5.** Results of stereographic projection of joints, slope, friction angle at stations 1, 2, 3, 4 and 5 (a, b, c, d, e); conditions for potential wedge landslides based on the classification of landslide types from stereographic results (f) (Hoek & Bray, 1981)

Stereographic analysis, wedge landslides are potential landslides at 5 observation stations. This is because the slope of the intersection plane of 2 sets of

discontinuities is smaller than the slope slope (tren/plunge) and tilts towards the face of the slope and, the internal friction angle is smaller than the intersection plane of 2 sets of discontinuities (Ab Aziza et al., 2026; Liu et al., 2024; Yuan et al., 2026). Based on the slope conditions at each station, rock mass conditions were found with many paired shear joints that have the direction of the slope of the joint plane in the same direction as the slope slope, this is one of the conditions for a slope to have the potential to experience wedge landslides.

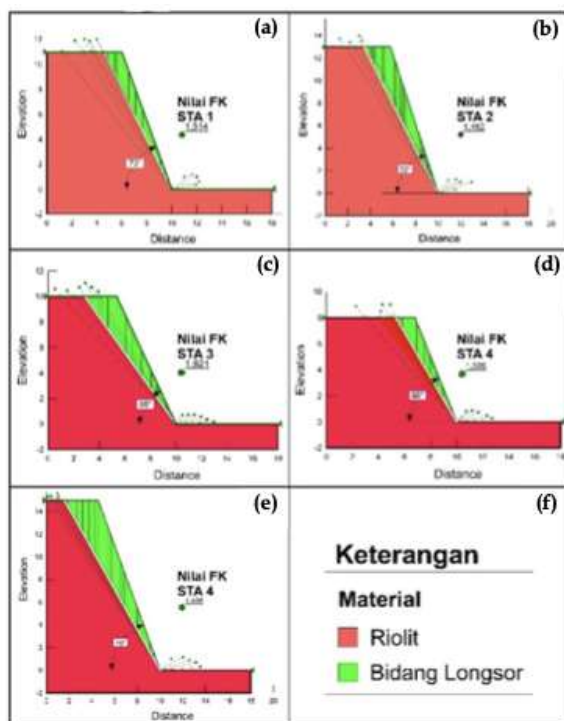
*Hoek & Brown* collapse criteria analysis which is entered into the FK processing software, namely GEOSTUDIO 2018 R2. The data is processed using the *Spencer method* which will produce a safety factor value. The value of the slope safety factor at observation station 1 is 1.514 (Landslides can occur). The value of the slope safety factor at observation station 2 is 1.482 (Landslides can occur). The value of the slope safety factor at observation station 3 is 1.921 (Landslides rarely occur). The value of the slope safety factor at observation station 4 is 1.595 (Landslides can occur). The value of the slope safety factor at observation station 5 is 1.408 (Landslides can occur).

**Figure 6.** Results of slope safety factor values at stations 1, 2, 3, 4 and 5 (a, b, c, d, e); description in figure a - d (f).

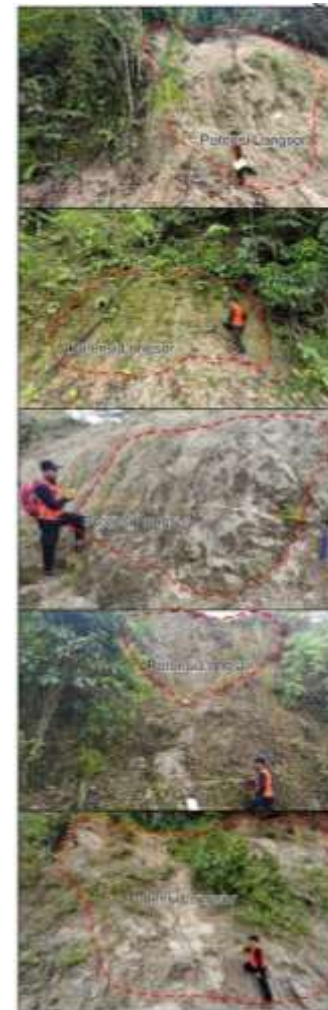
**Figure 7.** Appearance of slope conditions and landslide potential at stations 1, 2, 3, 4 and 5 (in order from top)

On the slopes of observation stations 1, 2, 4 and 5, there is a potential for landslides to occur which are classified as medium category or the slopes are in an unsafe condition due to weathering resulting from the geological structure deformation process which is characterized by the presence of fractures in the rock mass that makes up the slope and the influence of rainfall at this station significantly affects it, characterized by the condition of the weathered rock mass causing the rock mass to experience disintegration so that the rock mass that makes up the slope has the potential to collapse or landslide (Li et al., 2024; Nian et al., 2024). The condition of the slope at station 3 experiences weathering due to the deformation process, characterized by the presence of fractures in the rock mass and, the slope at this station is classified as low below 10 meters so that the material load at the top of the slope does not significantly affect the stability of the slope which results in the slope safety factor value at station 3 being at a low vulnerability level or landslides rarely occur (Figure 7).
